Reserve Study Update.com, LLC

Lacamas Shores Homeowners Association
PO Box 751
Camas, Washington 98607
Account 712 - Version 6

Fiscal Year: January 1, 2015 to December 31, 2015

RESERVE STUDY & MAINTENANCE PLAN

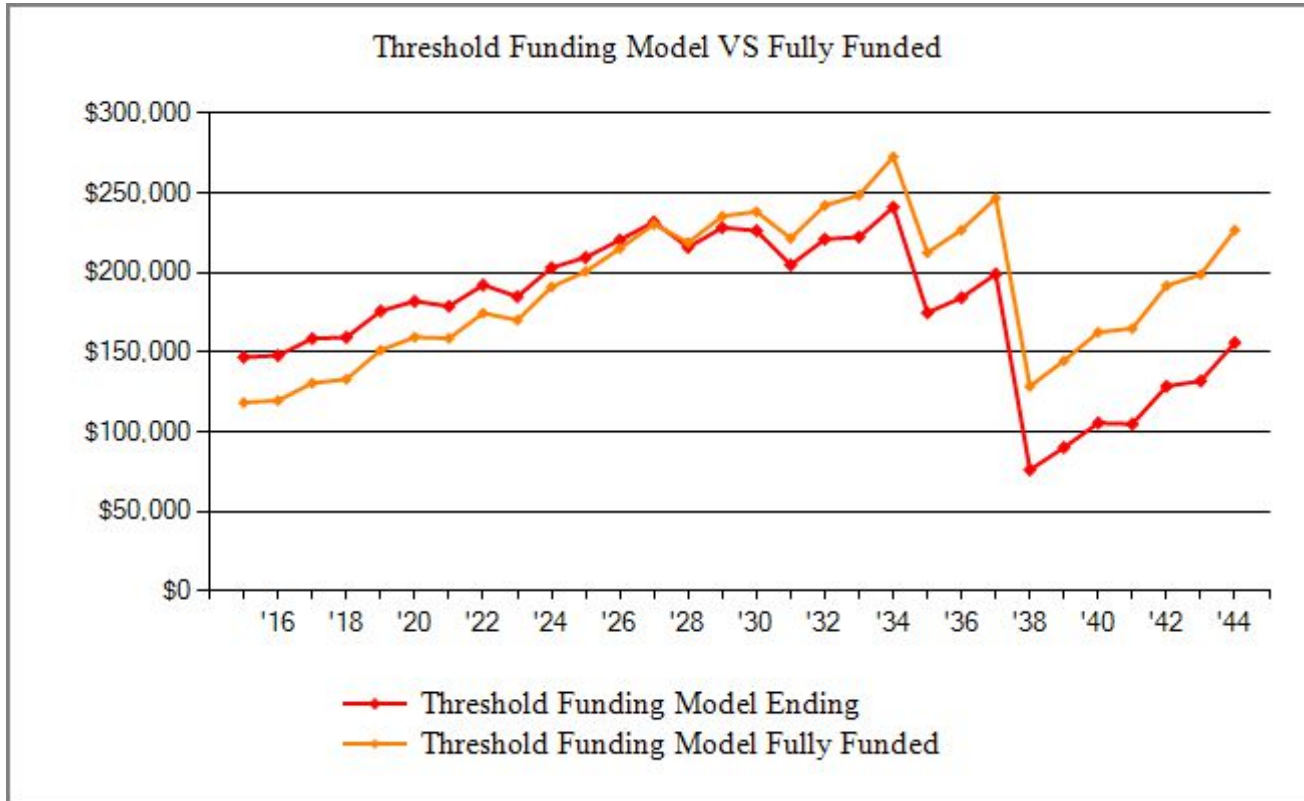
Lacamas Shores Homeowners Association
ReserveStudyUpdate.com, LLC Threshold Funding Model VS Fully Funded Chart

The **Threshold Funding Model** calculates the minimum reserve assessments, with the restriction that the reserve balance is not allowed to go below \$0 or other predetermined threshold, during the period of time examined. All funds for planned reserve expenditures will be available on the first day of each fiscal year. The **Threshold Funding Model** allows the client to choose the level of conservative funding they desire by choosing the threshold dollar amount.

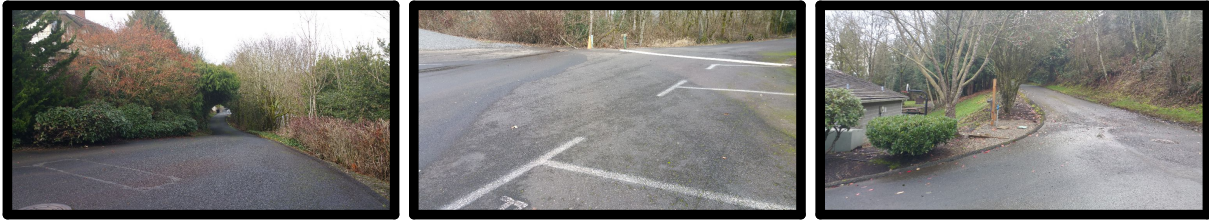
This line item is for the overlay replenishment along the entry ways and along the pathways. The Board is encouraged to seek an estimate from a paving company to affirm this estimate. Overlay appears to be in fair condition.

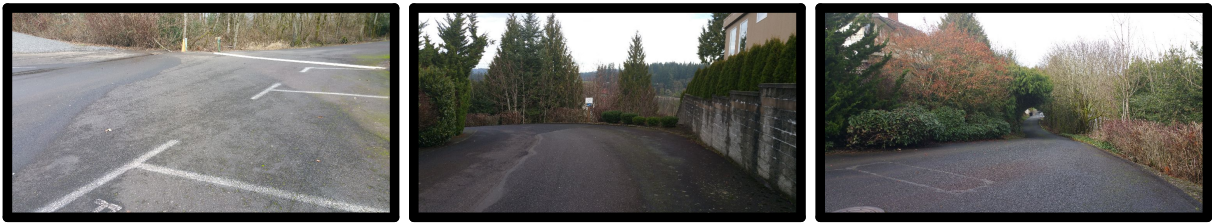
This line item is for the repairs needed to the asphalt overlays along the entry ways and along the pathways during the seal coat cycle. The Board is encouraged to seek an estimate from a paving company to affirm this estimate. Overlay appears to be in fair condition, however, repairs will be likely needed during the upcoming (and subsequent) seal coat cycles.

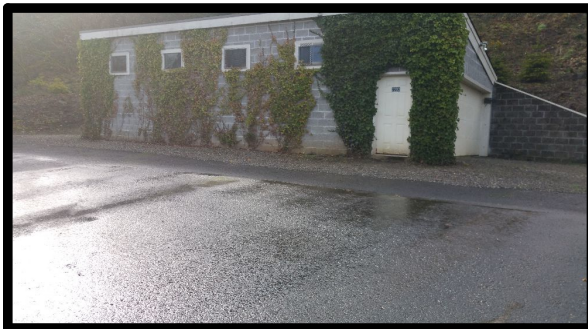
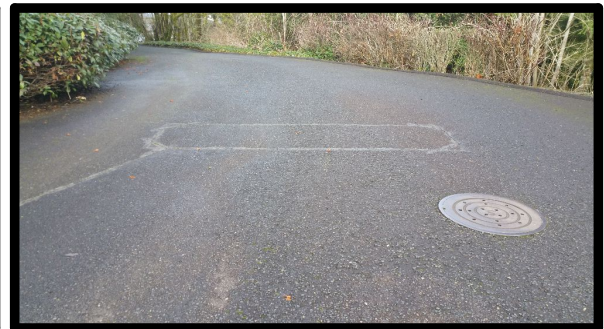
This line item is for the seal coat along the entry ways and along the pathways. The Board is encouraged to seek an estimate from a paving company to affirm this estimate. The seal coat is in fair condition and will likely require replenishment in the next 12 to 24 months.

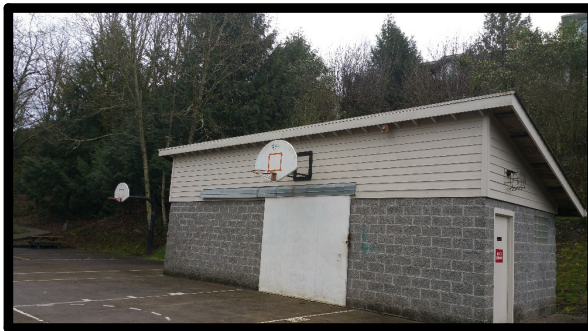
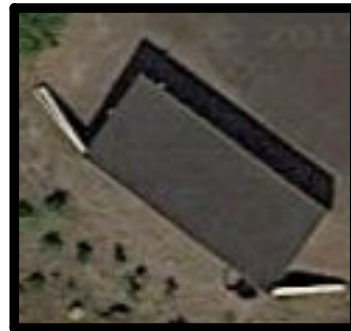
This line item is for the maintenance of the asphalt composition roof on the bathhouse. Roof was replaced in 2008 and is in good to fair condition. In order to maximize the life expectancy, the roof should be inspected and maintained at least every 3-5 years. This line item is to fund this activity.

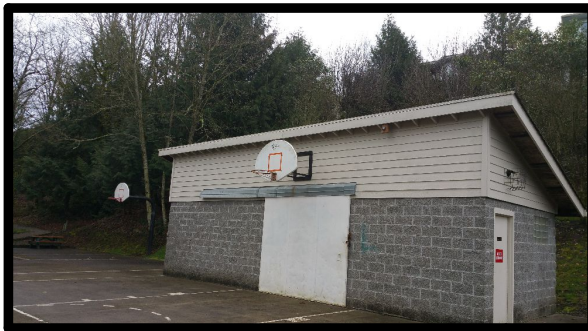
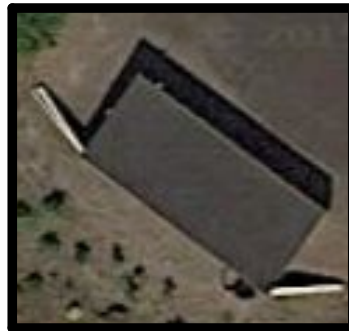
This line item is for the replacement of the asphalt composition roof on the bathhouse. Roof was replaced in 2008 and is in good to fair condition. In order to maximize the life expectancy, the roof should be inspected and maintained at least every 3-5 years.

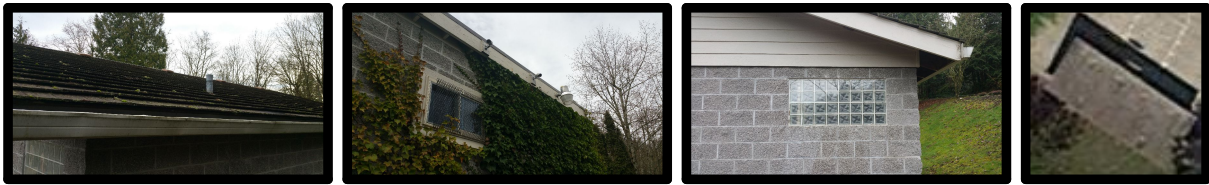
This line item is for the maintenance of the asphalt composition roof on the auxiliary building. Roof was replaced in 2008 and is in good to fair condition. In order to maximize the life expectancy, the roof should be inspected and maintained at least every 3-5 years. This line item is to fund this activity.

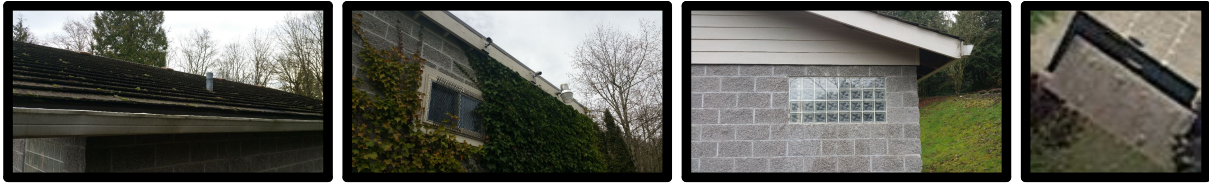
This line item is for the replacement of the asphalt composition roof on the maintenance auxiliary building. Roof was replaced in 2008 and is in good to fair condition. In order to maximize the life expectancy, the roof should be inspected and maintained at least every 3-5 years.

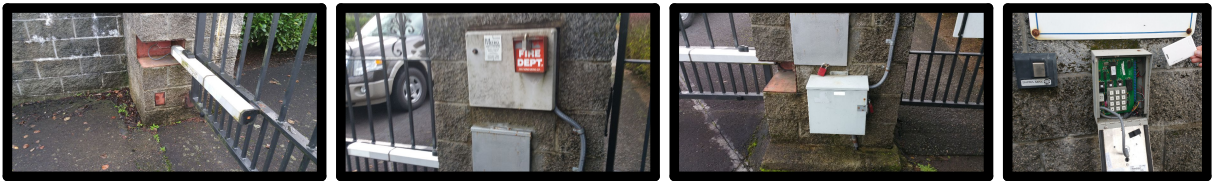
Gates: Vehicle - Automation

This line item is per a proposal from Metro Access Control dated 2/20/2015 which reads as follows:

- * AVERAGE LIFE OF AUTOMATION: 15 YEARS
- * AVERAGE LIFE OF IRON WORK: 30 YEARS
- * ESTIMATED AGE: 15 YEARS OLD

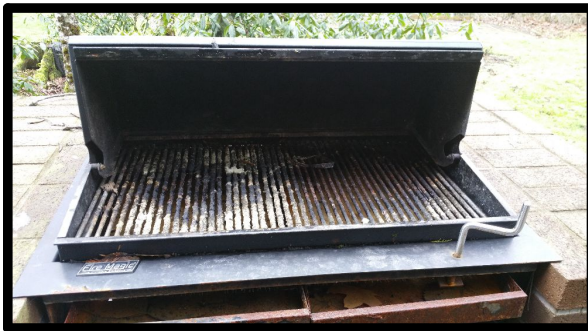
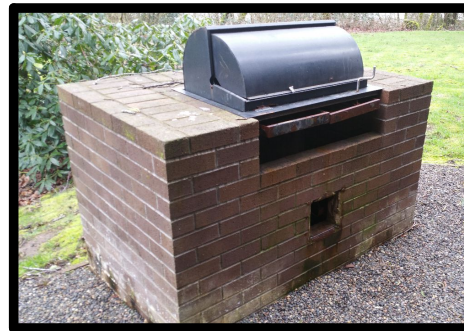
Barbeque - Replenish / Rebuild

This line item is for one of the three BBQ pits in the common area.

Per the Board, 2 of the 3 BBQ pits will be decommissioned. According to most governing documents, the process of removing an asset from the common area typically requires by the entire Association. Often times, this vote must be a supermajority approval or unanimous approval. This line item does not contemplate the process or outcome of any vote that may or may not be required. Nor are there any funds provided for the costs to facilitate any demolition. This line item simply funds only one barbeque per the Board.

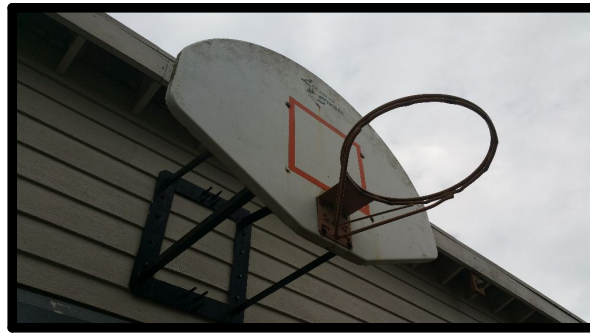
This line item is for the tear-down, disposal, replacement of the basketball goal, hoop, and associated mounting hardware. Costs are based upon similar units found at Big 5 Sports and installation. Hoop and goal appear to be in fair condition.

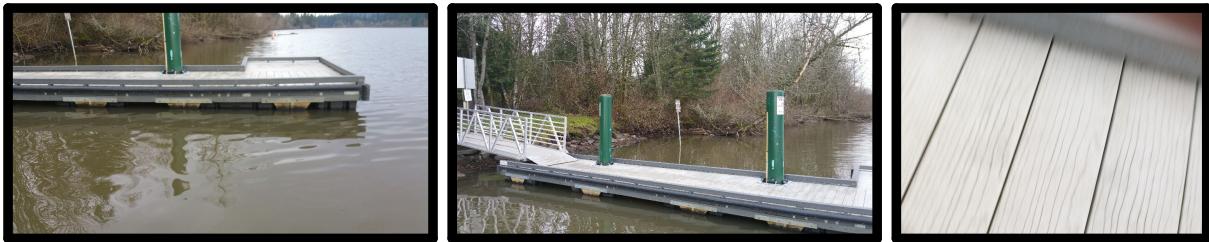
This line item is for the replacement of the boat dock every 25 years as necessary. Dock is constructed mainly of a Trex composite building material which is more durable than the original deck. Board is strongly encouraged to investigate the longevity of this material and the other components related to the deck as these components may fail sooner.

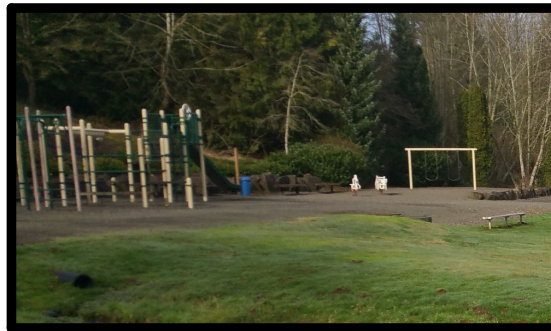
Playground / Exercise Equipment

This line item is for the major rebuild and replacement of portions of the various playground structures, fitness equipment including any cedar chips. Scope of work to be determined by the Board.

Suitable replacement parts may become difficult or impossible to find as overall system ages.

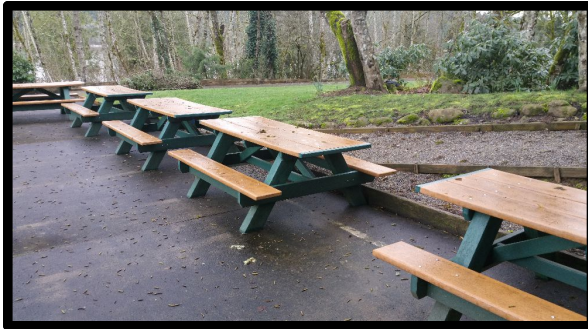
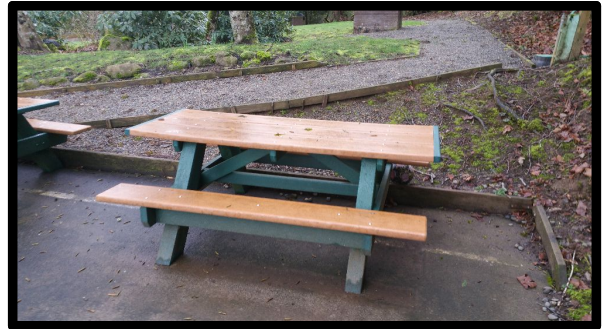
Site Furniture - Benches/Tables & Miscellaneous

This line item is for a provision for the replacement of the outdoor furniture such as the picnic benches in the common area from time-to-time. Total is based on a lump sum, therefore "Placed in Service" date is an approximation to properly commence the funding for this line item based on an overall average visual condition of components contained. Furniture appears to be in good overall condition. Cost based upon similar equipment available at Home Depot.

The Association should obtain a bid from a local certified, licensed, and bonded contractor in order to determine if this estimate and timing is sufficient to meet the needs of the Association. Cost presented herein assume that the full quantity specified will be addressed simultaneously in order to avoid possible overlap in mobilization charges and fees. The useful life of this component is predicated on the assumption the component was properly installed or applied. Costs projected assume that maintenance is performed on a periodic basis, which will significantly aid in components reaching the estimated life expectancy. These costs do not take into consideration any possible future increase in permit costs and fees that may be required.

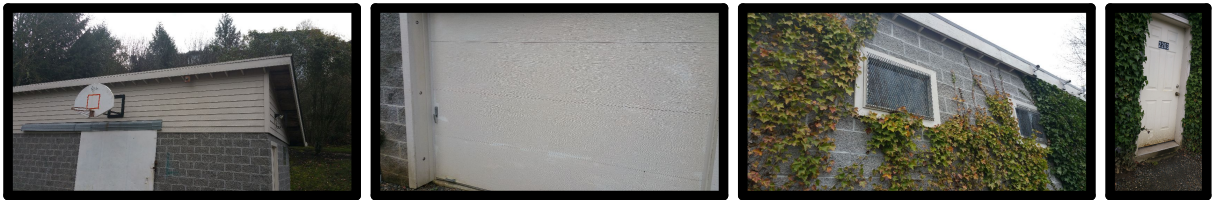
This line item is a provision for the replacement of windows and doors in the year 2028. Doors and windows are in good condition at this time. Therefore, we have extended the life by 10 additional years from the original anticipated replacement date. Should the Board determine that this approach is insufficient, the Reserve Analyst will adjust the report accordingly.

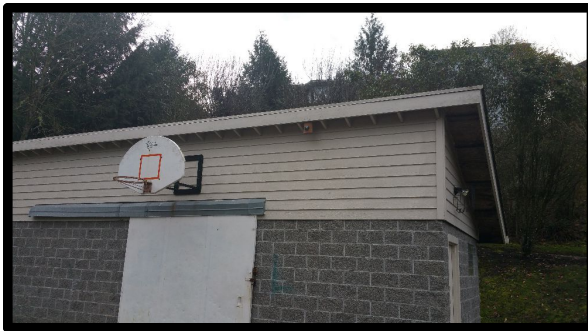
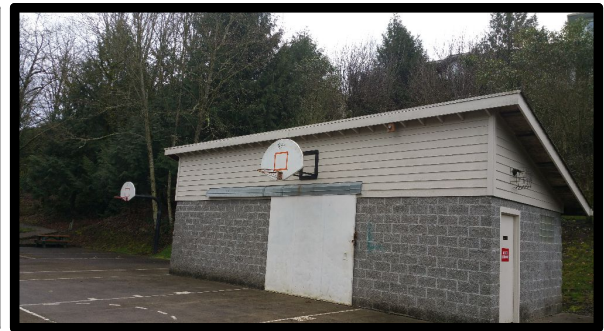
This line item is for the gutters and downspouts on the bathhouse building. Gutters should be cleaned every year. Gutters were recently repaired and are in fair condition.

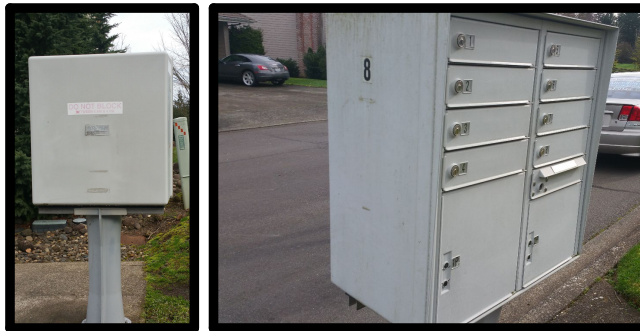
Mailbox - Replacement

This line item is for the occasional "here and there" replacement of mailboxes in the community. With proper ongoing maintenance mailboxes typically have an estimated life expectancy exceeding thirty years. However, some do fail from time to time; especially with a quantity as high as more than 30 total gang-cluster boxes, one or two (or more) clusters may fail every 5 years or so.

This line item assumes the replacement of 2 gang-cluster boxes every 5 years. This number may vary according to a variety of factors; some factors outside of the direct control of the Association such as vandalism or theft.

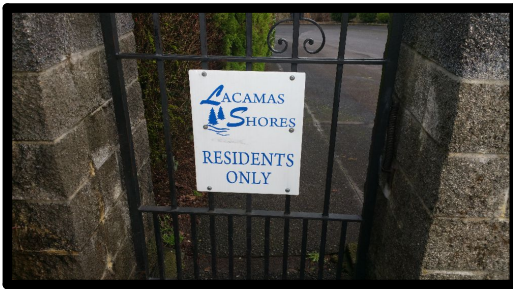
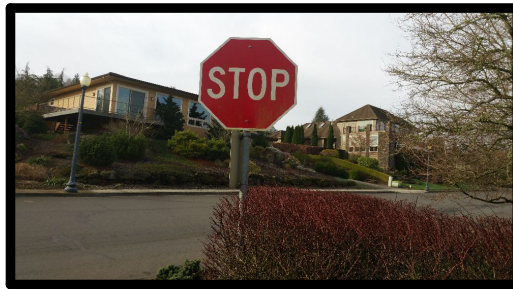
Street Signs

This line item is a contingency for the ongoing replacement of the various signs including street signs in the community. DOT signs should be manufactured with a reflective coating to insure visibility.

The Association should obtain a bid from a local certified, licensed, and bonded contractor in order to determine if this estimate and timing is sufficient to meet the needs of the Association. Cost presented herein assume that the full quantity specified will be addressed simultaneously in order to avoid possible overlap in mobilization charges and fees. The useful life of this component is predicated on the assumption the component was properly installed or applied. Costs projected assume that maintenance is performed on a periodic basis, which will significantly aid in components reaching the estimated life expectancy. These costs do not take into consideration any possible future increase in permit costs and fees that may be required.

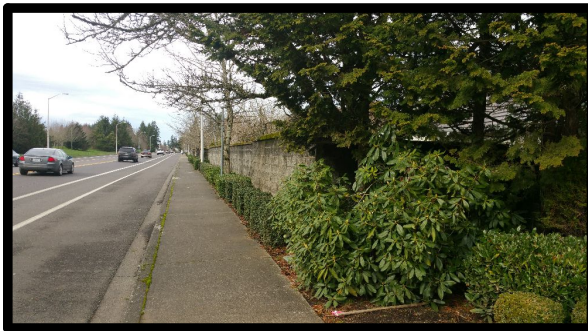
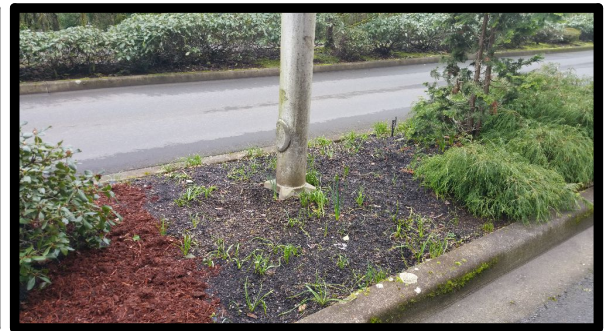
Arborist - Tree Work

This line item is for any major tree work that is beyond the scope of the landscaping contract. Cost include but not limited to; tree replacements, stump grinding, tree replacements, and major pruning.

The Association should obtain a bid from a local certified, licensed, and bonded contractor in order to determine if this estimate and timing is sufficient to meet the needs of the Association. Cost presented herein assume that the full quantity specified will be addressed simultaneously in order to avoid possible overlap in mobilization charges and fees. The useful life of this component is predicated on the assumption the component was properly installed or applied. Costs projected assume that maintenance is performed on a periodic basis, which will significantly aid in components reaching the estimated life expectancy. These costs do not take into consideration any possible future increase in permit costs and fees that may be required.

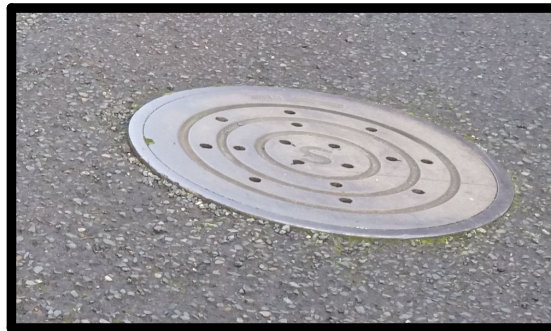
Underground Utilities

This line item is per the prior reserve study and is included in this reserve study report for the underground domestic water & sewer piping in the common and other areas which is not owned and maintained by a utility company. This line item may include storm drains, underground pipes, electrical conduits and wiring.

The Association should obtain a bid from a local certified, licensed, and bonded contractor in order to determine if this estimate and timing is sufficient to meet the needs of the Association. Cost presented herein assume that the full quantity specified will be addressed simultaneously in order to avoid possible overlap in mobilization charges and fees. The useful life of this component is predicated on the assumption the component was properly installed or applied. Costs projected assume that maintenance is performed on a periodic basis, which will significantly aid in components reaching the estimated life expectancy. These costs do not take into consideration any possible future increase in permit costs and fees that may be required.

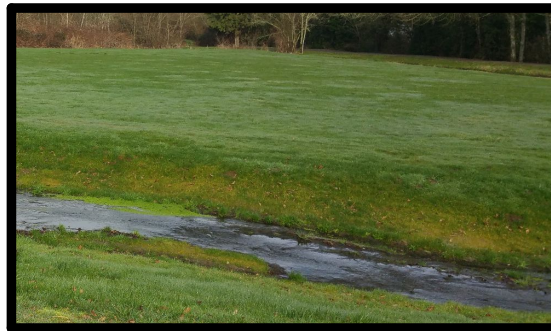
Storm Water Discharge Pond - Cleaning

This line item is for the major cleaning of the storm water discharge pond. Cost, timing, scope of work provided by Board. The Board of Directors purports that the scope of work conforms with all DEQ requirements.

The Association should obtain a bid from a local certified, licensed, and bonded contractor in order to determine if this estimate and timing is sufficient to meet the needs of the Association. Cost presented herein assume that the full quantity specified will be addressed simultaneously in order to avoid possible overlap in mobilization charges and fees. The useful life of this component is predicated on the assumption the component was properly installed or applied. Costs projected assume that maintenance is performed on a periodic basis, which will significantly aid in components reaching the estimated life expectancy. These costs do not take into consideration any possible future increase in permit costs and fees that may be required.

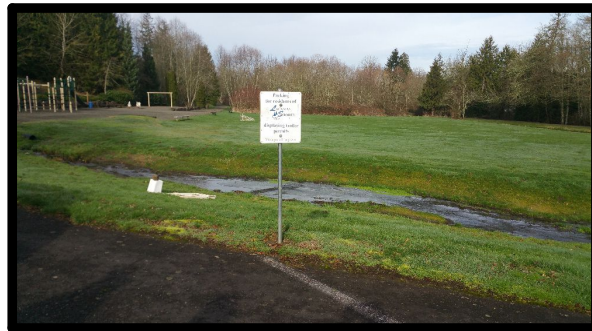
Stormwater Facility Swale Maintenance

The swale around the common-area soccer field treats runoff captured by the street drains around the neighborhood. These waters originally contained sediments and hydrocarbons and metals leached from the streets and from treated wood. As the neighborhood matured the impact to these water shifted from sediment to fertilizers, while the hydrocarbons and metals remained much the same.

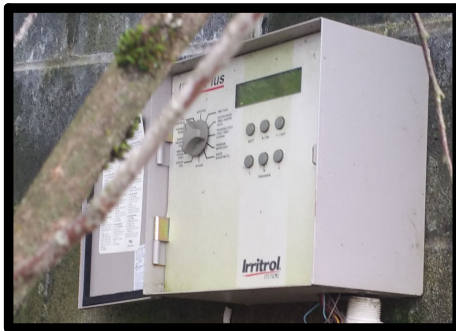
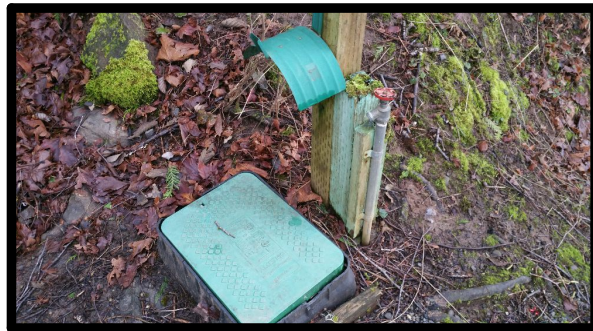
Irrigation Controllers & Valves

This line item is an ongoing provision for the replacement of the irrigation controllers and valves in the common areas of the community.

The Association should obtain a bid from a local certified, licensed, and bonded contractor in order to determine if this estimate and timing is sufficient to meet the needs of the Association. Cost presented herein assume that the full quantity specified will be addressed simultaneously in order to avoid possible overlap in mobilization charges and fees. The useful life of this component is predicated on the assumption the component was properly installed or applied. Costs projected assume that maintenance is performed on a periodic basis, which will significantly aid in components reaching the estimated life expectancy. These costs do not take into consideration any possible future increase in permit costs and fees that may be required.

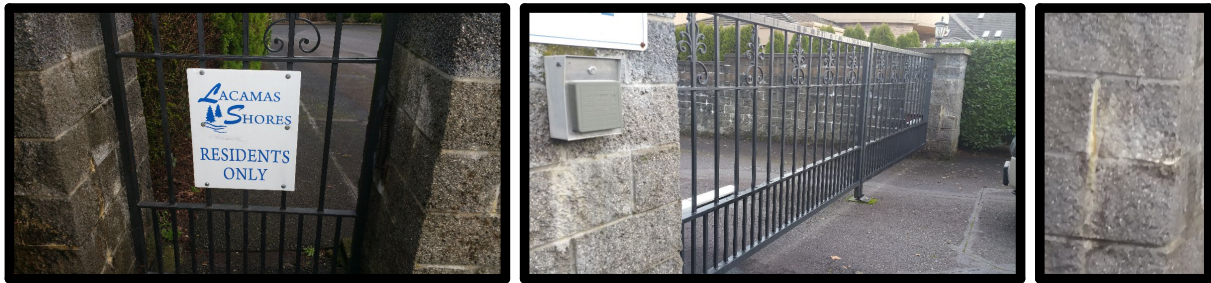
This line item is for the repointing of the masonry at the gate. Masonry appears to be in fair condition. Analyst recommends reevaluating this condition on an annual basis; by either the Board or an on-site reserve analyst, but preferably a professional mason.

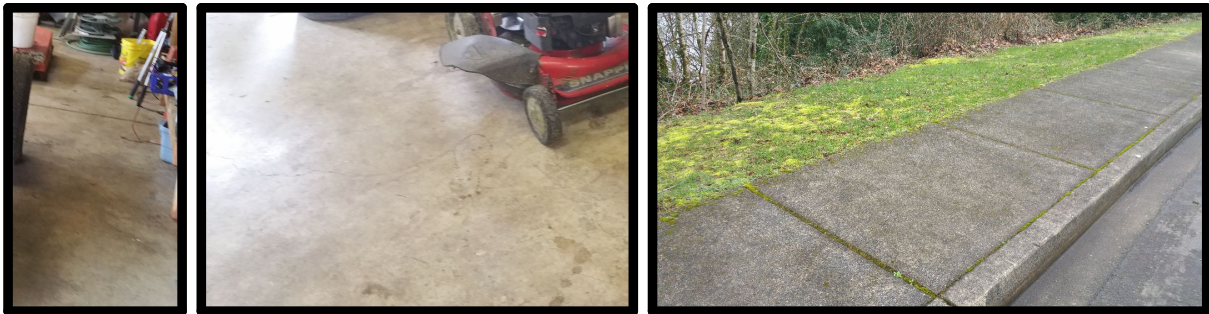
Concrete - Common Areas - Provision

This line item is a contingency for the concrete surfaces in the community including concrete floors, flatwork, driveway aprons, curbs, vehicle stops, and other areas as needed. This contingency only funds 5% replacement of all estimated concrete surfaces in the community.

The Association should obtain a bid from a local certified, licensed, and bonded contractor in order to determine if this estimate and timing is sufficient to meet the needs of the Association. Cost presented herein assume that the full quantity specified will be addressed simultaneously in order to avoid possible overlap in mobilization charges and fees. The useful life of this component is predicated on the assumption the component was properly installed or applied. Costs projected assume that maintenance is performed on a periodic basis, which will significantly aid in components reaching the estimated life expectancy. These costs do not take into consideration any possible future increase in permit costs and fees that may be required.

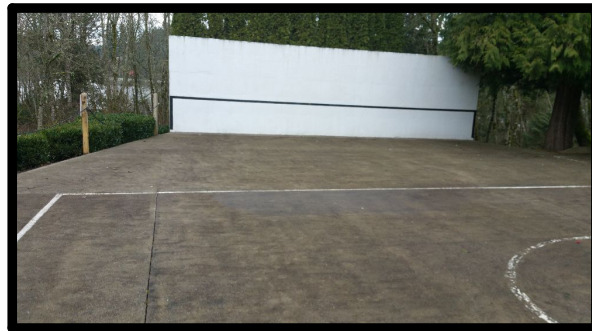
This line item is for the replacement of the concrete sport court every 30 years, or as needed. Sport court appears to be in good condition.

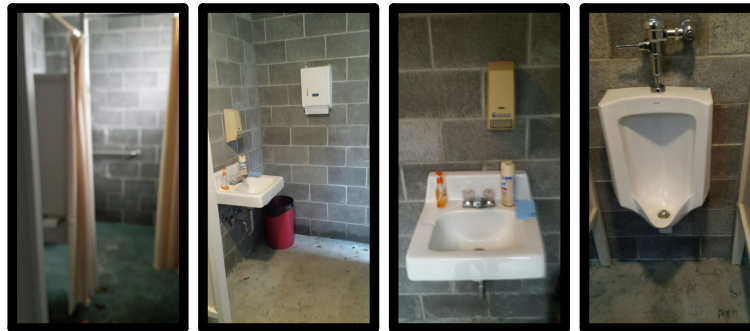
Restroom Refurbishment - Provision

This line item is for replacement of the various fixtures, in the restrooms. Analyst concedes that equipment will have a variable life expectancy; depending on a variety of external factors such as hours of use, security and possible vandalism. (or lack thereof)

The Association should obtain a bid from a local certified, licensed, and bonded contractor in order to determine if this estimate and timing is sufficient to meet the needs of the Association. Cost presented herein assume that the full quantity specified will be addressed simultaneously in order to avoid possible overlap in mobilization charges and fees. The useful life of this component is predicated on the assumption the component was properly installed or applied. Costs projected assume that maintenance is performed on a periodic basis, which will significantly aid in components reaching the estimated life expectancy. These costs do not take into consideration any possible future increase in permit costs and fees that may be required.

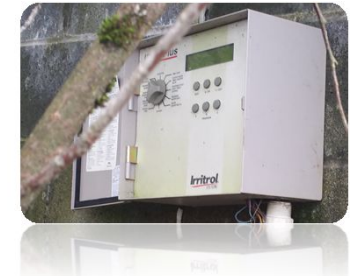
When an electrical impulse is transmitted to the solenoid, an electromagnetic field causes a small metal plunger in the solenoid to move upward. When the plunger moves upward, a small hole in the valve is uncovered which allows the water in the chamber above the closing mechanism to flow through the port and out of the valve, relieving water pressure needed to hold the valve closed. The pressure of the incoming flow of water is greater than the pressure in the chamber above the piston, and the force of the water pushing up underneath the piston opens the valve. When the solenoid is de-energized, the plunger moves down, closing the small port. Water flowing through a small hole in the closing mechanism refills the chamber above the piston and builds up pressure. The increased pressure forces the piston downward, thus closing the valve. All valves have a range of pressure and water flow that must be maintained in order to work properly.
